Cyclic Fatigue Testing of Surface Mooring Hardware for the Arabian Sea Mixed Layer Dynamics Experiment

UOP Technical Report 95-5

WHOI-95-16 UOP 95-05

December 1995

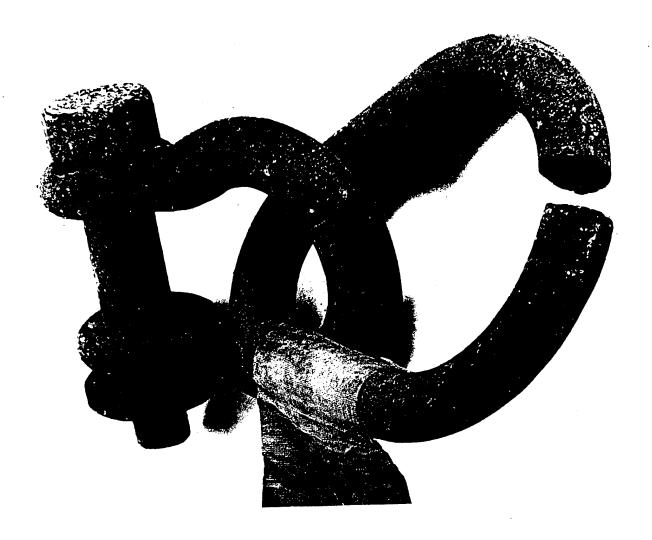
Little was known about the fatigue properties of standard components used in-line on a mooring prior to the 1989 pilot mooring for the Office of Naval Research (ONR) funded Marine Light in the Mixed Layer (MLML) experiment (Plueddemann *et al.*, 1995). The MLML pilot mooring was deployed in April 1989, approximately 300 miles south of Iceland in 2845 meters of water. Though the mooring was intended to remain on station for 5 months it failed after only 70 days. A 5/8 inch Crosby Laughlin weldless sling link with a rated working load of 4200 pounds and an ultimate breaking strength of six times the working load limit (WLL) was the component that failed (Figure 1). A high frequency tension data logger at the base of the MLML pilot mooring buoy bridle recorded tensions that ranged from less than 1000 to over 8500 pounds which was well under the ultimate breaking strength of the sling link. Tension records showed changes of up to 5000 pounds over less than four seconds.

To investigate this problem the manufacturer of the slings links, Crosby, agreed to perform a series of cyclic tests at their facility in Tulsa, Oklahoma, on the 5/8" sling links. Links were cycled between 2000 and 4000 pounds at 5 cycles per second. Inspections were made after 500,000, 1,000,000, and 2,000,000 cycles; however there were no obvious changes. The loading was changed to cycle between 420 and 6300 pounds, i.e., from a low load equal to 10% of the WLL to a high load equal to 1.5 times the WLL. Failure occurred after 52,800 cycles.

Figure 1: Photograph and manufacturer specifications of the 5/8" weldless sling link that failed during the 1989 deployment of the Marine Light in the Mixed Layer experiment pilot mooring.
